DEPARTMENT OF TRANSPORTATION

Contract #: 04-0120F4Cty: SF/ALA Rte: 80 PM: 13.2/13.9File #: 69.28**WELDING INSPECTION REPORT****Resident Engineer:** Siegenthaler, Peter**Address:** 333 Burma Road**City:** Oakland, CA 94607**Report No:** WIR-018347**Date Inspected:** 19-Nov-2010**Project Name:** SAS Superstructure**OSM Arrival Time:** 700**Prime Contractor:** American Bridge/Fluor Enterprises, a JV**OSM Departure Time:** 1900**Contractor:** Zhenhua Port Machinery Company, Ltd (ZPMC), Changxing Island **Location:** Shanghai, China**CWI Name:** Xu Le Feng, Geng Wei**CWI Present:** Yes No**Inspected CWI report:** Yes No N/A**Rod Oven in Use:** Yes No N/A**Electrode to specification:** Yes No N/A**Weld Procedures Followed:** Yes No N/A**Qualified Welders:** Yes No N/A**Verified Joint Fit-up:** Yes No N/A**Approved Drawings:** Yes No N/A**Approved WPS:** Yes No N/A**Delayed / Cancelled:** Yes No N/A**Bridge No:** 34-0006**Component:** OBG/TOWER**Summary of Items Observed:**

Bay # 10, South Tower lift 5, Capping plate (NWIT # 7411)

Bay # 14, OBG Bottom Plate (NWIT # 7416)

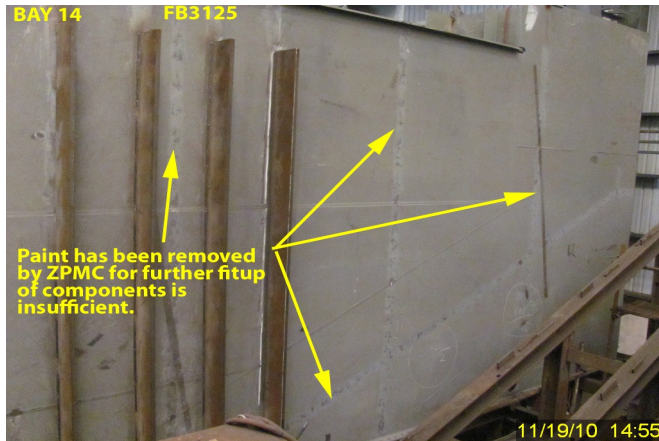
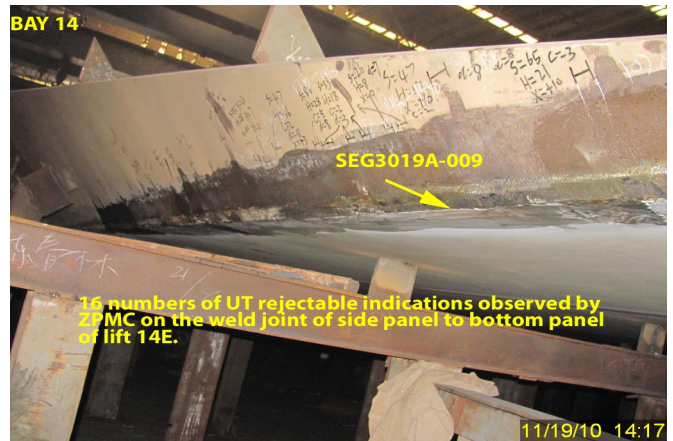
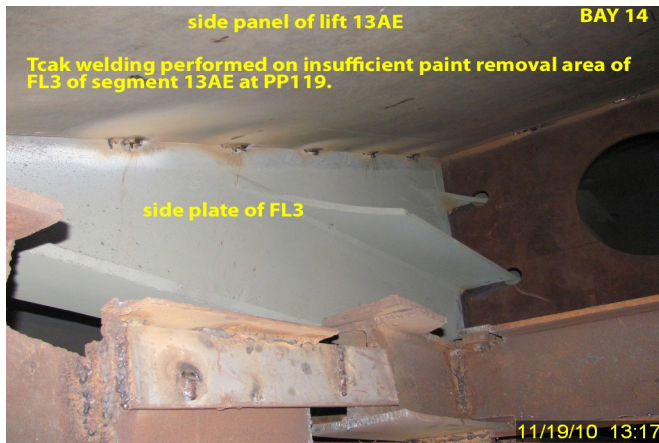
During random in process inspection this QA inspector observed that insufficient paint has been removed for the

fit up of further components. Side panel of FL3 area connected to segment 13AE at panel point PP119 has been tack welded, but the paint removed on the tack welded area was observed to be insufficient. This issue has been discussed with lead QA and lead QA discussed this issue with ZPMC CWI Mr. Geng Wei. Mr. Geng Wei informed this QA that this issue would be corrected in a manner compliant with the contract documents. Attached photograph provides additional information.
